NEW ZEALAND NOTICES TO MARINERS

NZ 19 – 29

NUMERICAL INDEX OF CHARTS AFFECTED
(NZ NTM Edition No.1 dated 9 January 2009)

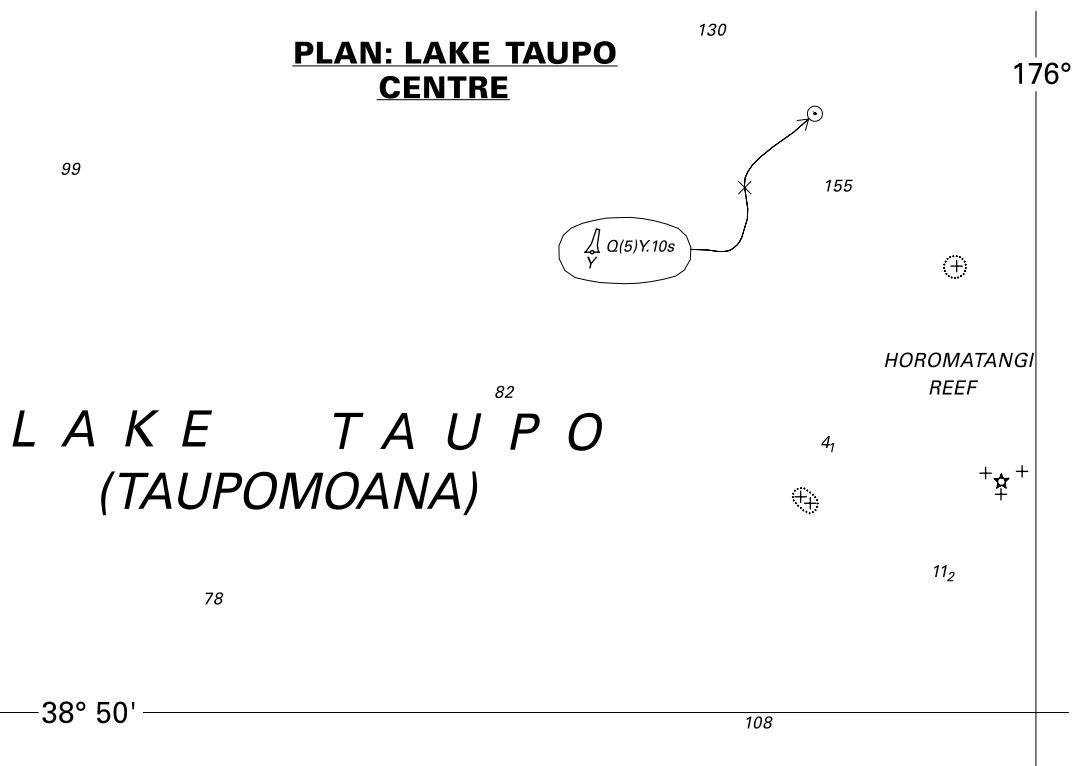
Chart NZ 232 [117/08]

NZ 22/09 NEW ZEALAND – North Island – Lake Taupo (Taupomoana) – Scientific Buoy.

Q(5)Y.10s

38° 46'.83S., 175° 58'.43E.

Insert
