NEW ZEALAND NOTICES TO MARINERS

Notices
NZ 21-27

II**NUMERICAL INDEX OF CHARTS AFFECTED***(NZ NTM Edition No.2 dated 20 January 2012)*

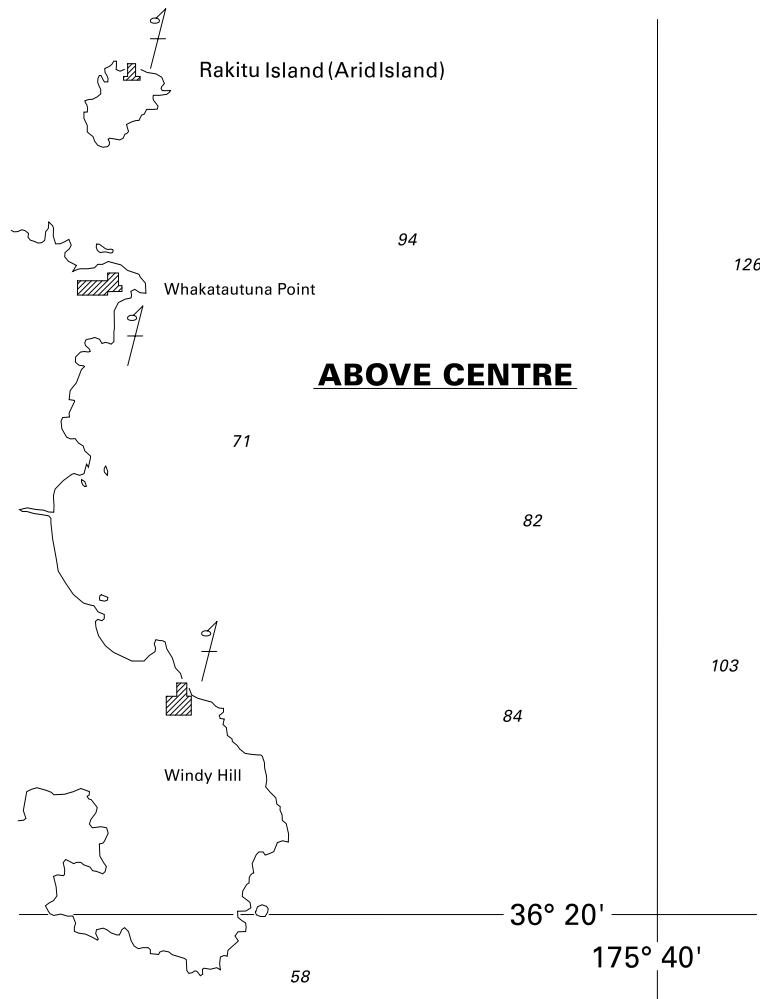
Chart NZ 53 [251/11]

NZ 21/12 NEW ZEALAND – North Island – East Coast – Great Barrier Island – Beacons.

Delete

36° 07'.18S., 175° 30'.07E.

36° 10'.42S., 175° 29'.76E.

36° 16'.71S., 175° 31'.04E.

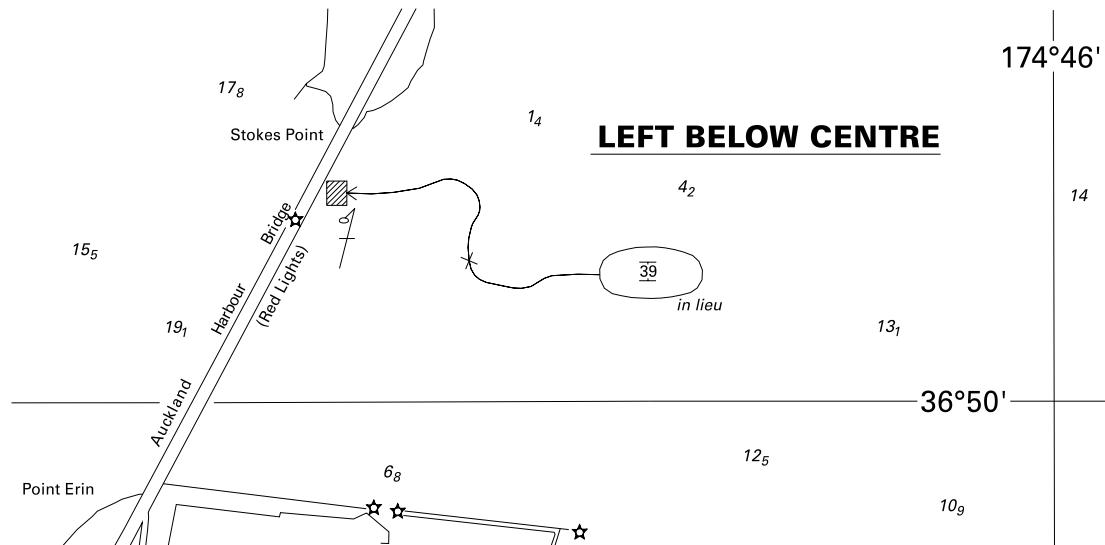
Chart NZ 5322 [184/11]

NZ 22/12 NEW ZEALAND – North Island – East Coast – Auckland Harbour – Auckland Harbour Bridge – Vertical Clearance.

Amend Vertical clearance of Bridge to 39m 36° 49'.73S., 174° 44'.85E.

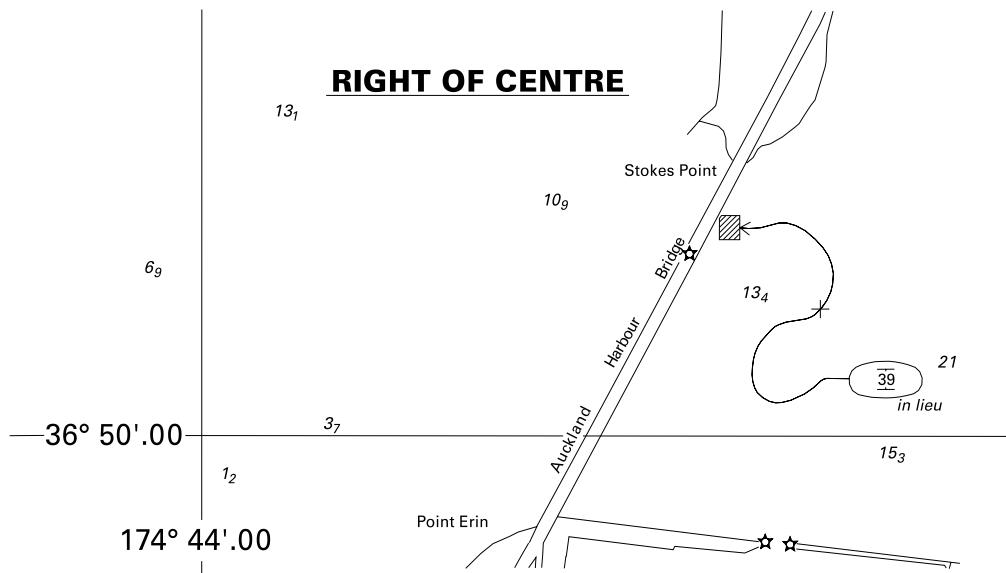
Chart NZ 5323 [232/11]

Amend Vertical clearance of Bridge to 39m 36° 49'.73S., 174° 44'.85E.

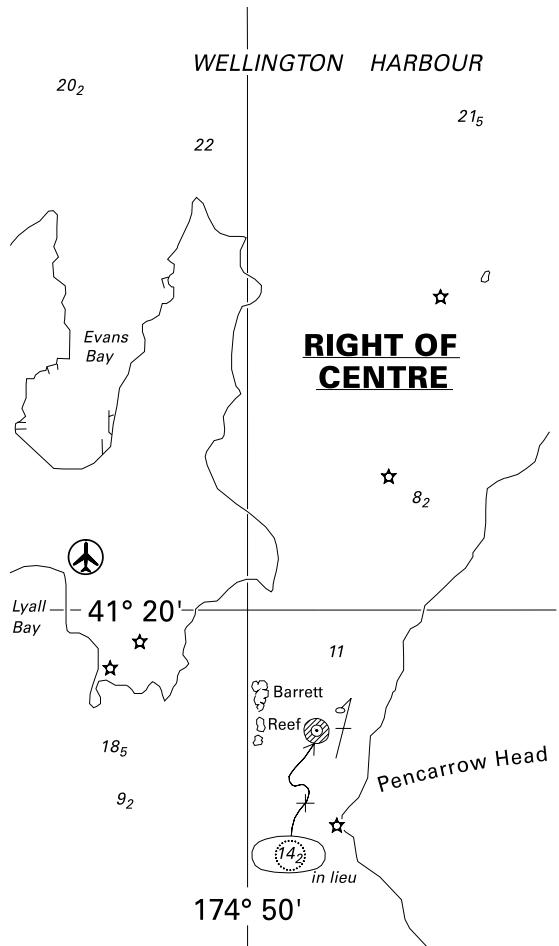
Chart NZ 463 [NE Mar 11]

NZ 23/12 NEW ZEALAND – North Island – South Coast – Wellington Harbour - Obstruction.

Amend ~~12₈~~ to 14₂ 41° 20'.86S., 174° 50'.65E.

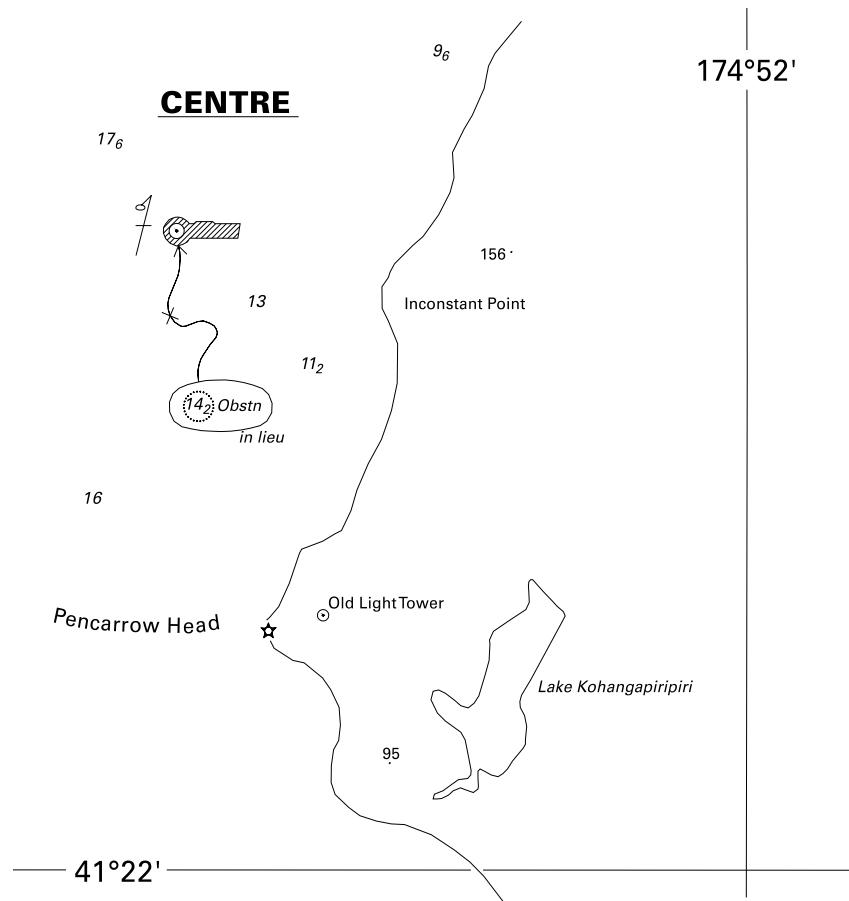
Chart NZ 4633 [117/11]

Amend ~~12₈~~ *Obstn* to 14₂ *Obstn* 41° 20'.86S., 174° 50'.65E.

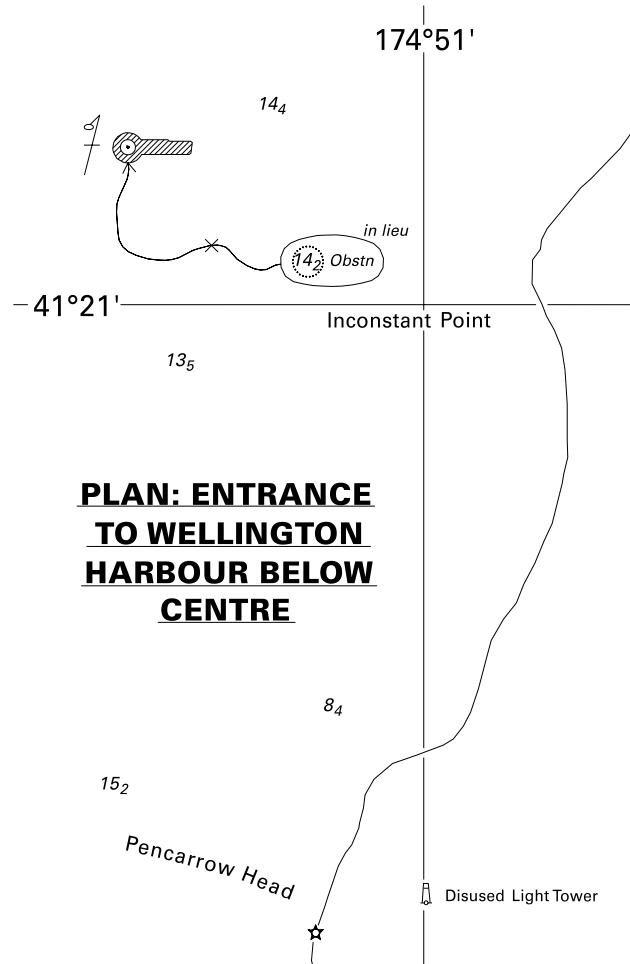
Chart NZ 4634 (plan, Entrance to Wellington Harbour) [106/11]

Amend ~~12₈~~ *Obstn* to 14₂ *Obstn* 41° 20'.86S., 174° 50'.65E.
